# Studying Streambanks Reveals Their Weaknesses and Strengths

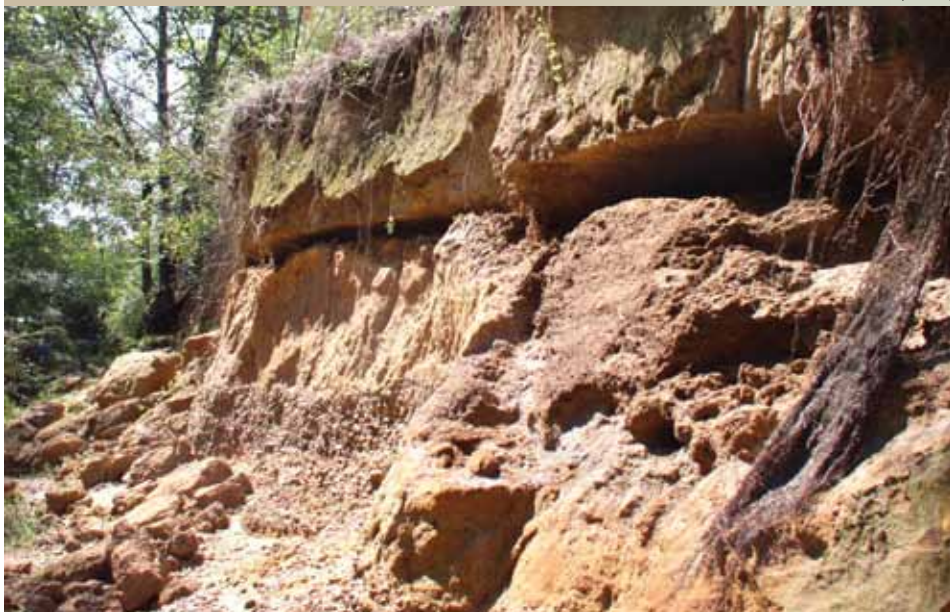
GLENN WILSON (D2063-1)

An example of seepage erosion from a section of Goodwin Creek in Mississippi.

But Wilson and Fox found examples of undercut bank failures that had occurred in low-flow streams. When they took a closer look at these banks, they saw evidence that seepage out of streambanks was eroding out layers of soil. The eroded soil layers washed down the face of the streambank and into the stream itself, adding to the sediment load in the stream and leaving the bank weakened and vulnerable to collapse due to having undercuts from the washed-out layers.

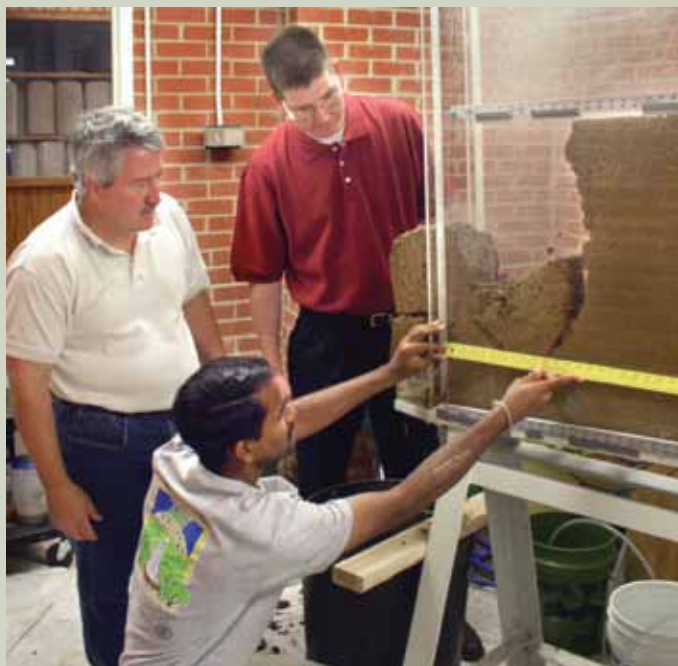
ARS hydrologist Glenn Wilson (left), graduate student Raja Periketi (center), and Oklahoma State University scientist Garey Fox use a simulated streambank to conduct laboratory experiments of seepage erosion on streambank failure. Periketi is measuring the lateral extent of a mass failure caused by seepage erosion.

The scientists gathered enough field data on seepage erosion processes to develop lab models and refine their understanding of how seepage could exacerbate eventual streambank failure. In the lab, they could control bank depth and seepage flow rates—and they could safely observe the sometimes-sudden collapse of a massive wall of dirt.

Wilson and Fox confirmed for the first time that a stable streambank can quickly become unstable when seepage erosion is added to the mix of factors that promote bank failure. The probability of failure reached 100 percent when the degree of undercutting reached about 30 to 50 millimeters (1 to 2 inches) into the bank face. The researchers concluded that streambank failure may stem as much—or more—from the effect of seepage erosion undercutting the streambanks as from the added weight of the waterlogged soil as seepage increases.
